**CULTURAL RESOURCES SURVEY OF
THE SCE&G SALUDA DAM COMPLEX,
LEXINGTON COUNTY, SOUTH CAROLINA**

CULTURAL RESOURCES SURVEY OF THE SCE&G SALUDA DAM COMPLEX, LEXINGTON COUNTY, SOUTH CAROLINA

Prepared By:
Michael Trinkley, Ph.D.
and
Nicole Southerland

January 8, 2001
Revised September 7, 2001

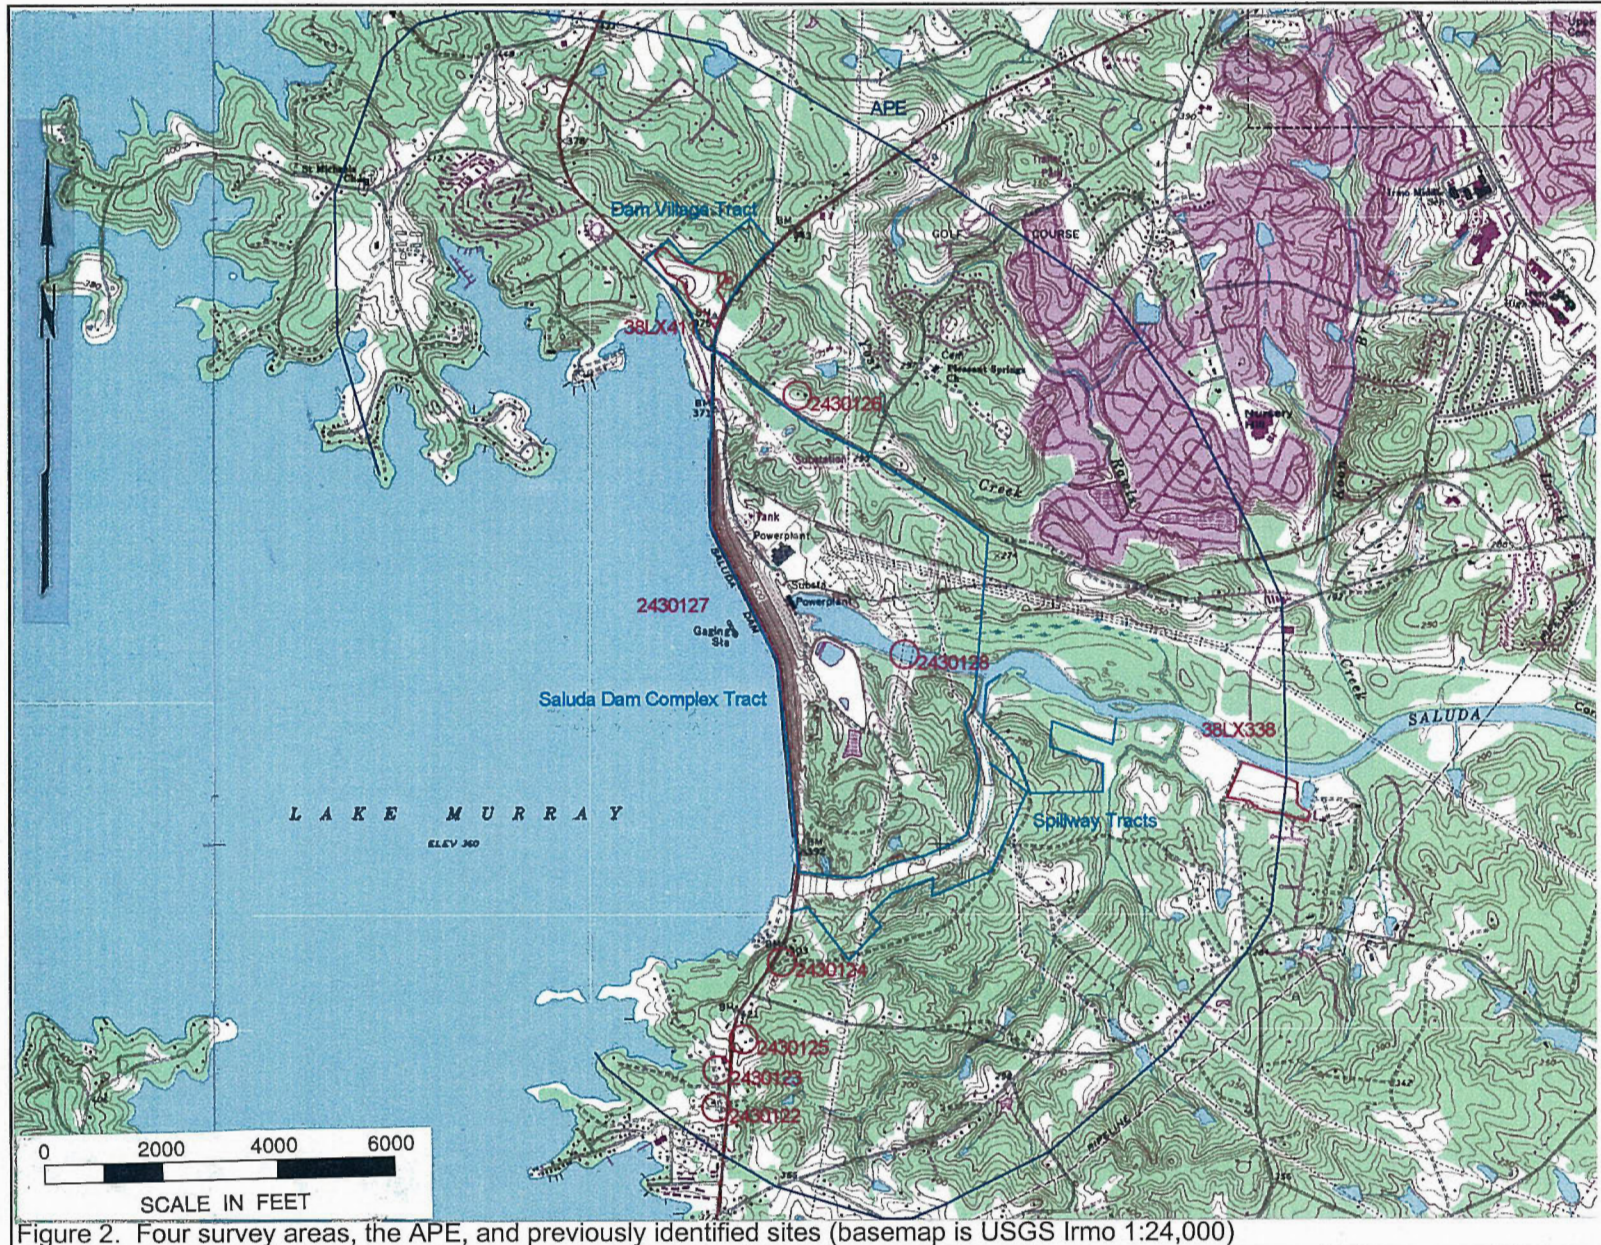
Figure 2. Four survey areas, the APE, and previously identified sites (basemap is USGS Irmo 1:24,000)

The Saluda Dam Complex study tract is roughly rectangular, measuring about 7,500 feet north-south by 3,000 feet east-west. The northern boundary is Bush River Road (S-107). The eastern boundary is a straight line which runs south from Bush River Road to the Saluda River and continues southward across the Saluda on the spillway bank. This spillway also forms the southern boundary of the project. The western boundary is the existing Saluda (Lake Murray) Dam (Figure 2).

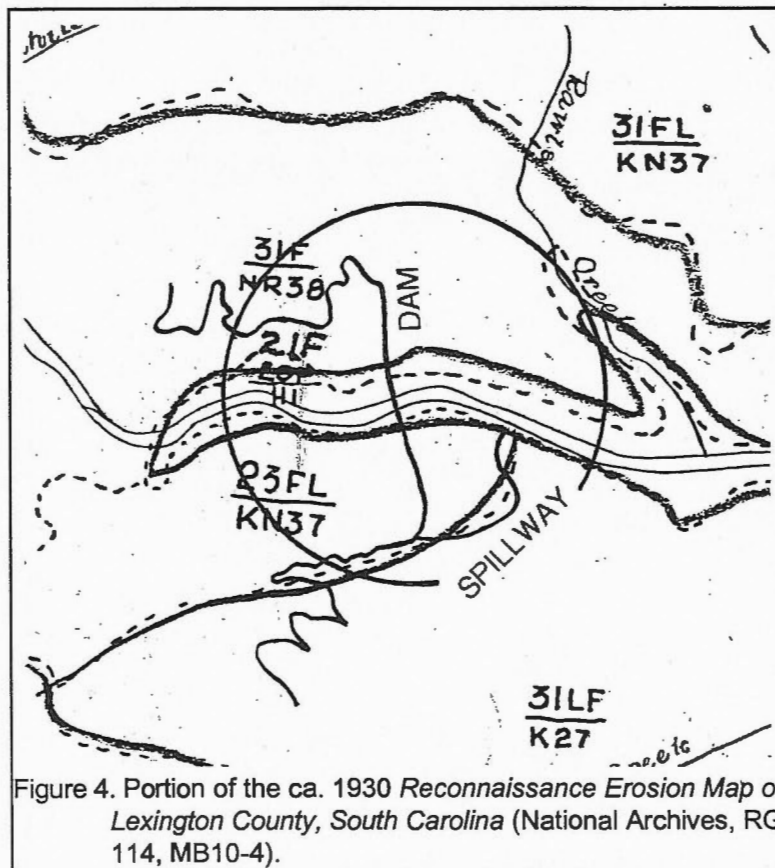
Figure 4. Portion of the ca. 1930 Reconnaissance Erosion Map of Lexington County, South Carolina (National Archives, RG 114, MB10-4).

provided by the undated (ca. 1930) *Reconnaissance Erosion Map of Lexington County*, produced by M.W. Lowry and C.B. Gay (National Archives, RG 114, MB10-4). This map (Figure 4) reveals that all of the area on the north side of the Saluda River was classified as "Severe Sheet Erosion Frequent Gullies," while on the south side the condition was only marginally better, with the soils identified as "Severe Sheet Erosion Occasional Gullies."

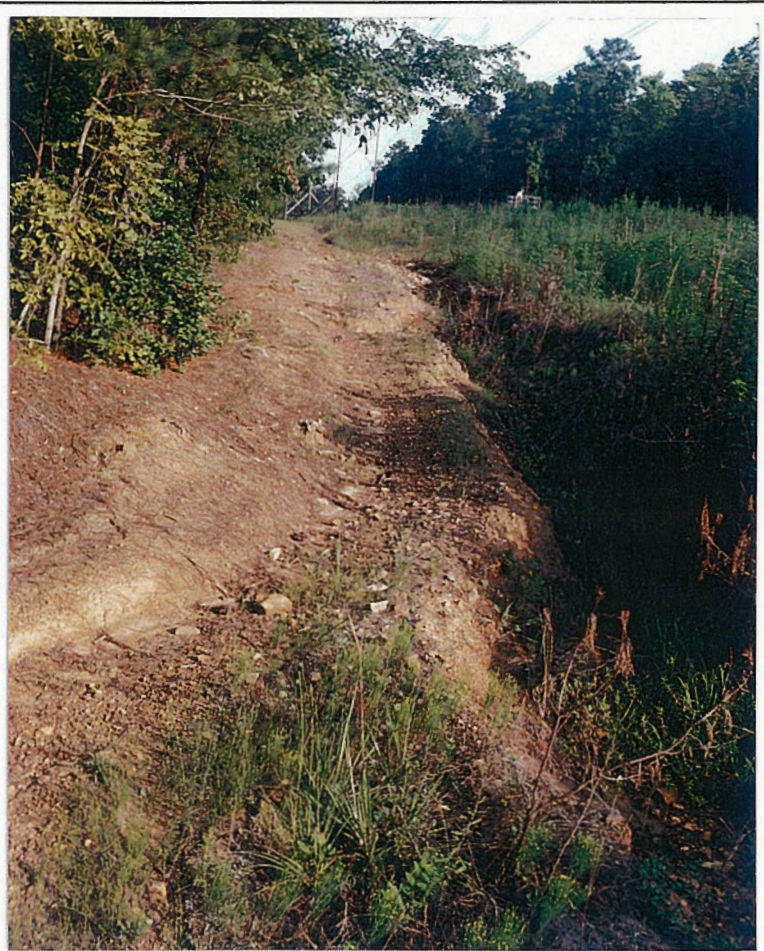
Figure 5. Area of still active erosion on a road adjacent to a powerline easement in the study area.

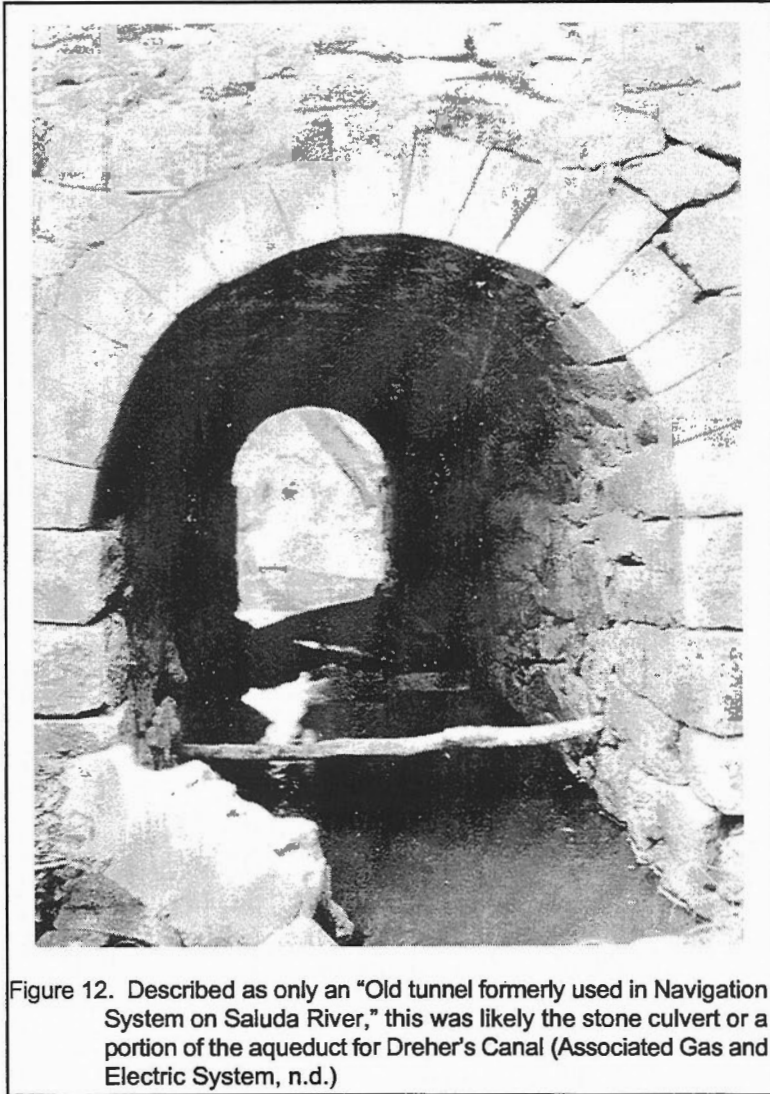
Figure 12. Described as only an "Old tunnel formerly used in Navigation System on Saluda River," this was likely the stone culvert or a portion of the aqueduct for Dreher's Canal (Associated Gas and Electric System, n.d.)

in the canal, was found necessary to give protection to the works below. The canal crosses two ravines and one creek, requiring two culverts and one aqueduct. The whole of this canal has been excavated. One culvert and the aqueduct have been constructed — One occupation bridge, for the use of Drehr's mills, has been erected. The guard lock and dam are now building, and a considerable quantity of cut stone for the works

is prepared. A stone building for the Lock-keeper has its walls nearly up. The water that descends the ravine near the head of the works, cannot be discharged without passing very near the bottom of the canal. This space will not receive a stone culvert; one of cast iron has therefore been prepared, and most of the pieces are already delivered. The castings for such a culvert, 60 feet long and 22 inches interior diameter, cost \$300 (Kohn and Glenn 1938:42).

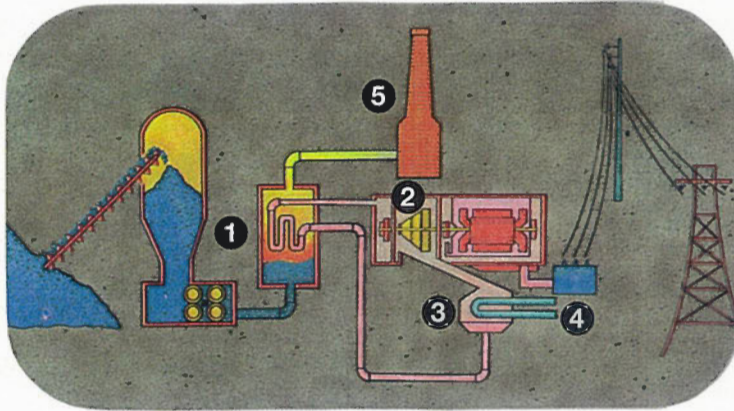
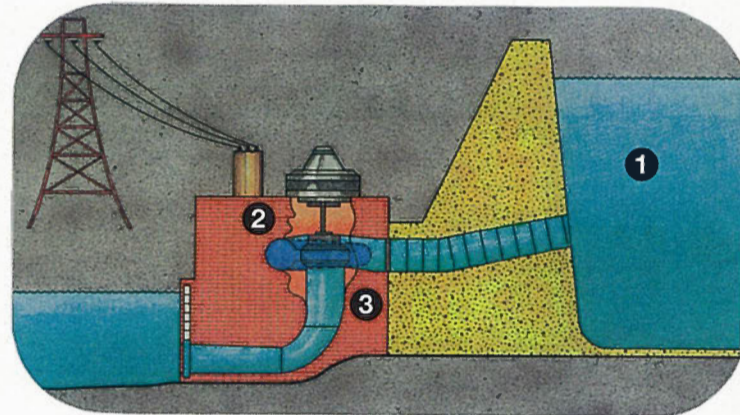
In a fossil fuel plant:

1. Coal, ground into a fine powder, is burned inside a boiler producing steam.
2. Steam spins blades on the turbine which turns the generator producing electricity.
3. Steam is cooled in a condenser by water from a nearby river or lake. The cooled steam, now water, returns to the boiler and the cycle is repeated.
4. The cooling water returns to the lake or river, going through cooling towers to remove built-up heat.
5. Electrostatic precipitators in the stack clean up exhaust gases.

In a hydroelectric plant:

1. Water held in the reservoir behind a dam is allowed to enter the powerhouse through penstocks.
2. Water turns the turbine generator producing electricity.
3. The water is then released.

Figure 16. Operation of hydroelectric and fossil fuel plants (adapted from "SCE&G Generation").

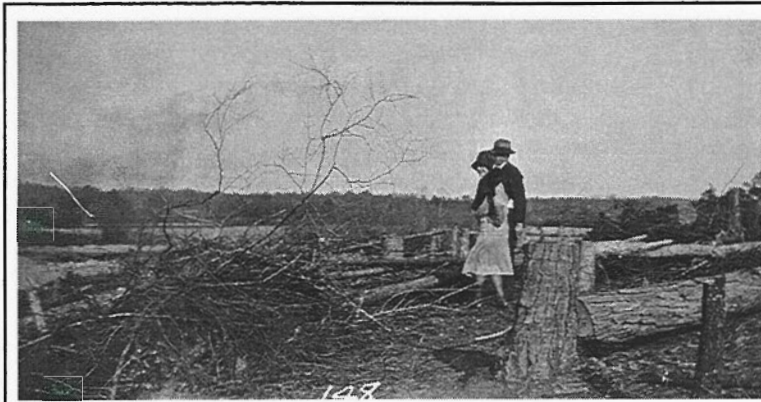
Figure 17. View of floodpool during logging (courtesy of SCE&G).

With the acquisition of the necessary lands construction began March 1, 1927. Logging crews removed the timber from 44,666.2 acres, resulting in about 55 million board feet (Federal Power Commission 1932:47). Much of this timber was sold to contractors working on the dam, the remainder was either burned or wired to the ground to prevent it from floating as the basin was eventually flooded (Figure 17).

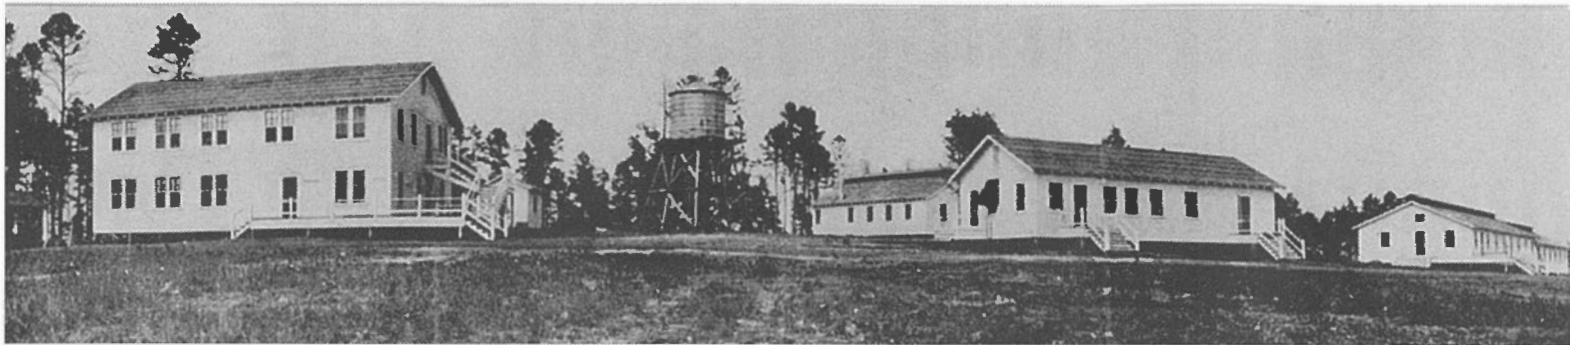
Figure 19. "Panorama View of Administration Building, Mess Hall, Land Office Building and Bunk House" (courtesy of SCE&G).

Campsites for the workers were established in the immediate area. Pogue notes that the Arundel Corporation, contractor for the dam construction, built camps that accommodated about 1,500 workers. A village (The Saluda Dam Village) of nine structures and a church were built 0.5 mile north of the dam.² Figure 18 shows the layout of these structures, while Figure 19 is a period photograph taken looking to the northeast.

Several surface features were encountered while performing the survey. Three 4.0 foot square concrete slabs with steel wire cables connected on top were found near the northern site boundary. These slabs were the base of the water tower (seen in Figure 19). Immediately under the water tower was a valve and an exposed pipe. Nearby is a brick valve pit measuring about 3 feet square, with three valve wheels. It is likely that these valves controlled the water flow to the various buildings. Between the slabs and valve pit was wood rubble which may have been the base

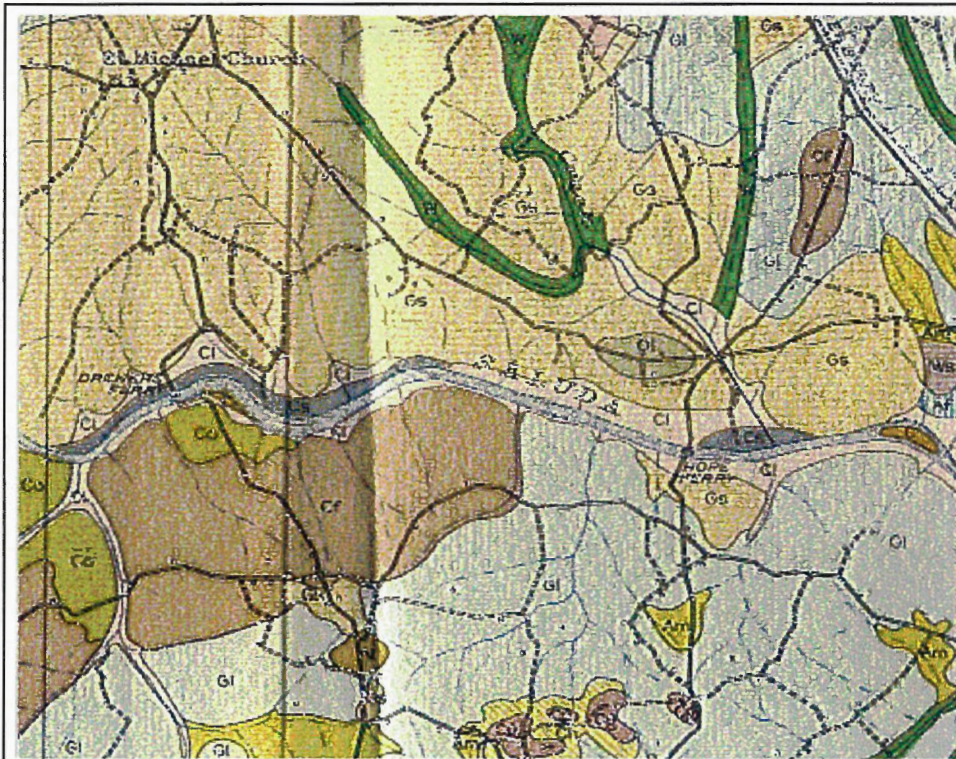
Figure 20. Portion of the 1922 Lexington County soil survey showing structures in the survey area.

Of particular concern to this project are the locations of structures in the study tract. Figure 20 is a portion of the 1922 Soil Survey map of Lexington County showing the area from Hope Ferry to Dreher Ferry (Shoals). There are two areas where structures are found. On the north side of the Saluda, off what is Bush River Road, is a farm road with four structures (two on each side of the farm road). On the south side of the Saluda River a road loops up crossing what would

Figure 21 shows the dam area. Adjacent to Bush River Road there is one structure — representing the complex shown in this area on the 1922 soil survey (Figure 20). No other structures are shown, suggesting that they may have been dilapidated, removed by this time, or perhaps were not dwellings. At the south end of the dam the map shows the location of the Yninger Cemetery, marked as "Graveyard."

Figure 20 shows the location of the cemetery before construction removed much of

the north side of the road which may have been associated with the well (see Figure 20).

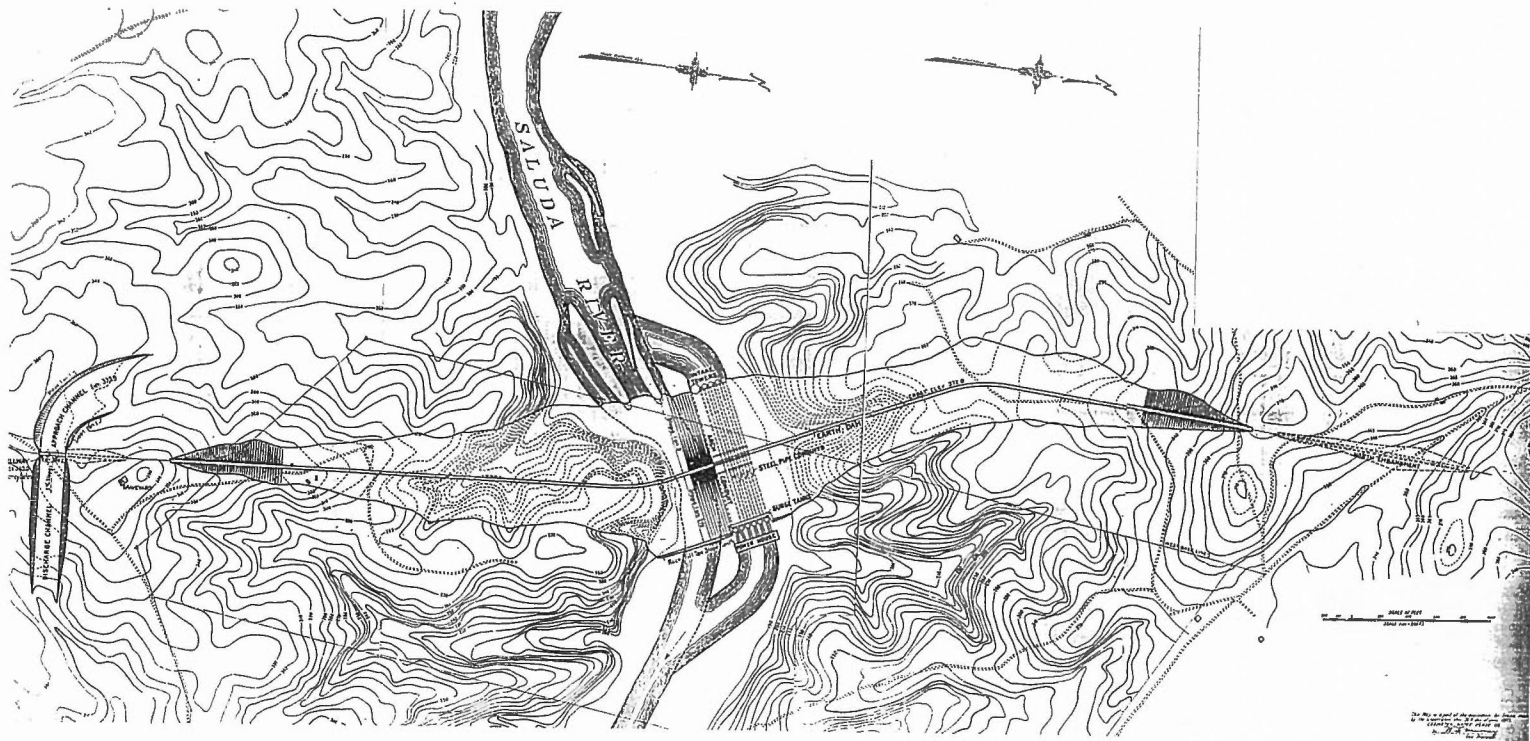
Figure 21. Pre-construction map of the dam area (Federal Power Regulatory Commission, Permit 516, Exhibit K, Items 516-11 and 12).

1922 soil map and on the pre-construction plan were the Schuler farm. This plan shows the "Temporary Detour Bridge," as well as the powerhouse, discharge channel (which is now the flow of the river), and substation. Also shown are the Lexington Water Power Co. Temporary Buildings at the northwest edge of the tract. Further to the east, set back from Bush River Road, was the hospital.

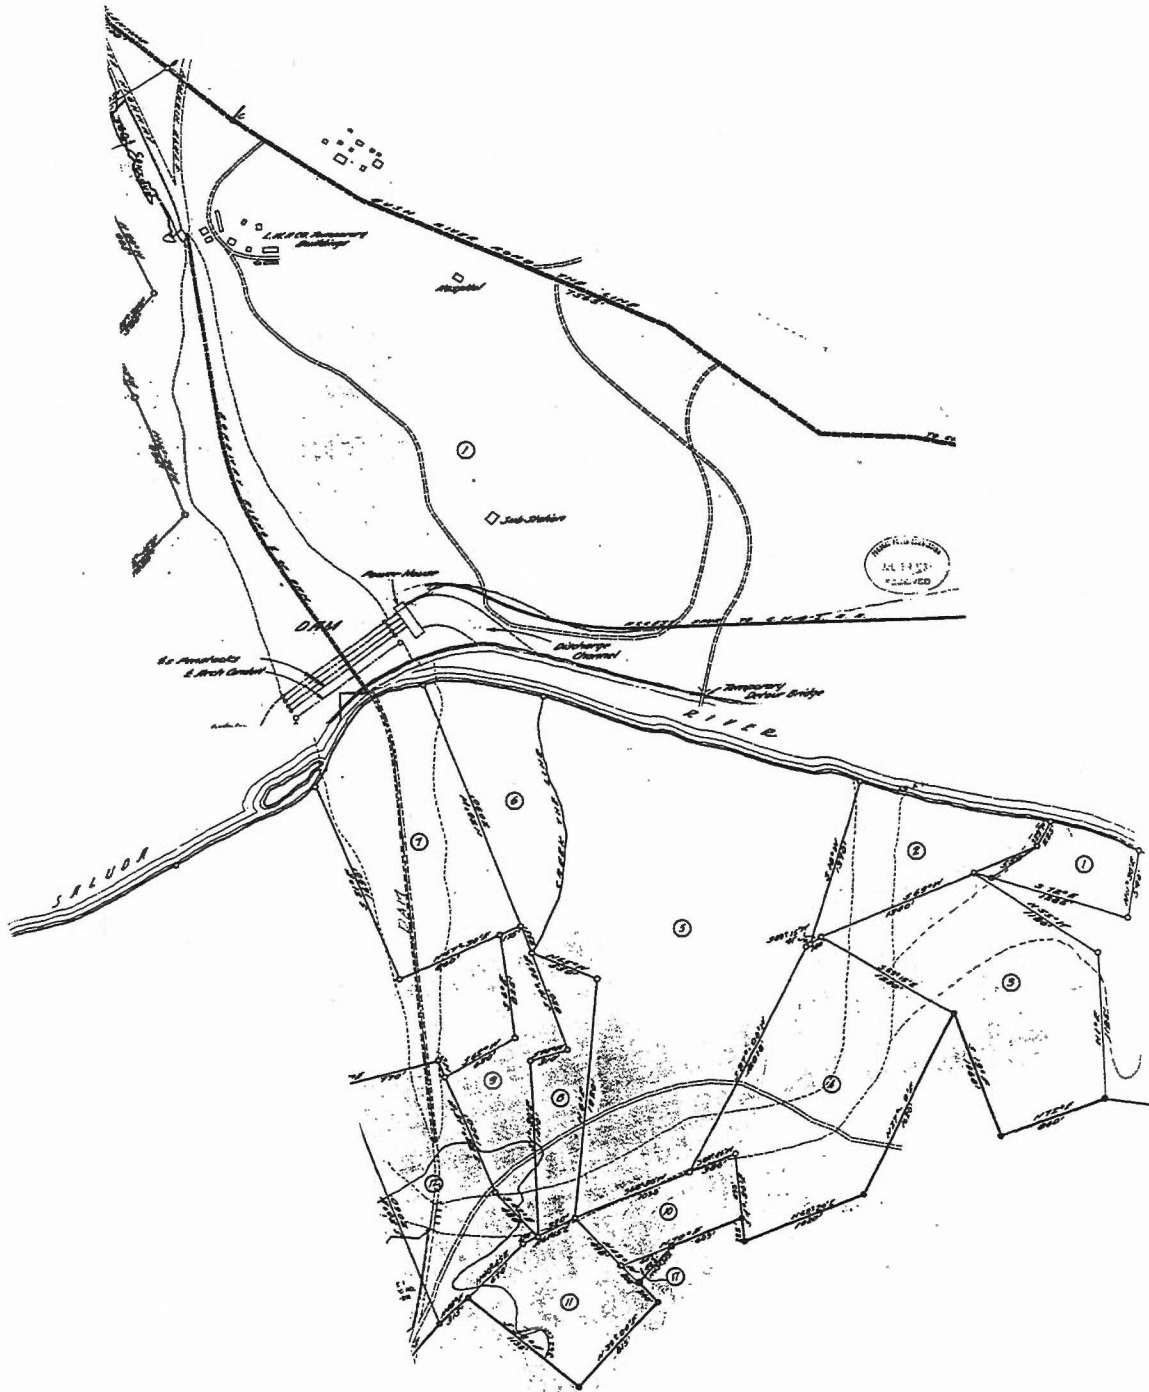
Figure 22. Land Atlas of the dam area, sheets 1 and 2 (Federal Power Regulatory Commission, Permit 516, Exhibit K-1).

Figure 22 shows the survey areas after the completion of the dam construction. While this doesn't provide information on pre-existing structures, it does indicate landowners. On the north side of the Saluda the project was contained entirely to the land of Mrs. Annie C. Schuler, identified as Option 1 and accounting for 546.3 acres. It is likely that the structures shown on the

None of the Lexington Water Power Company temporary buildings shown in Figure 22 were still standing, although a new office building had been erected. The hospital was likewise removed. The area of these original buildings appears deeply scarred and partially terraced. What is today a wetland area in this vicinity is shown only as dark, wet soil with no

This area was historically in the immediate area of not only the road and railroad, but also large stockpiles of construction materials (see Figure 22). The identified materials may represent scatter from a construction zone, supplemented by modern debris (the window glass and beer bottle) and transmission line maintenance (the 1931 insulator). In other words, this scatter of materials may not actually represent any one activity, but rather a range of activities taking place at a "cross-roads" locale in a construction area. The sparseness of subsurface materials is likely the result of the area being partially graded.

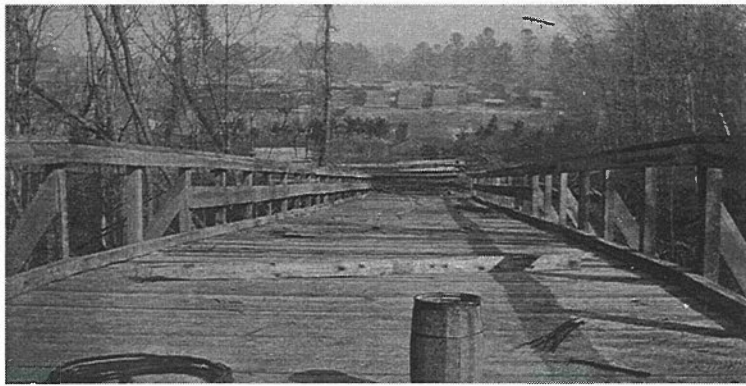
Figure 23. Temporary bridge under construction. To the north is the lumber storage yard and rail spur (courtesy of SCE&G).

A temporary bridge was constructed across the Saluda River (Figures 23 and 24), downstream from the construction. This wooden bridge was set on a series of four lumber and stone piles in the Saluda, which remain today. The road and bridge allowed residents to move freely back and forth, replacing the "Steel Bridge" at Wises Ferry that would ultimately be covered by the waters of Lake Murray. On the main dam property north of this temporary bridge photographs reveal a large stockyard of lumber, as well as the spur railroad line. The area is cleared and

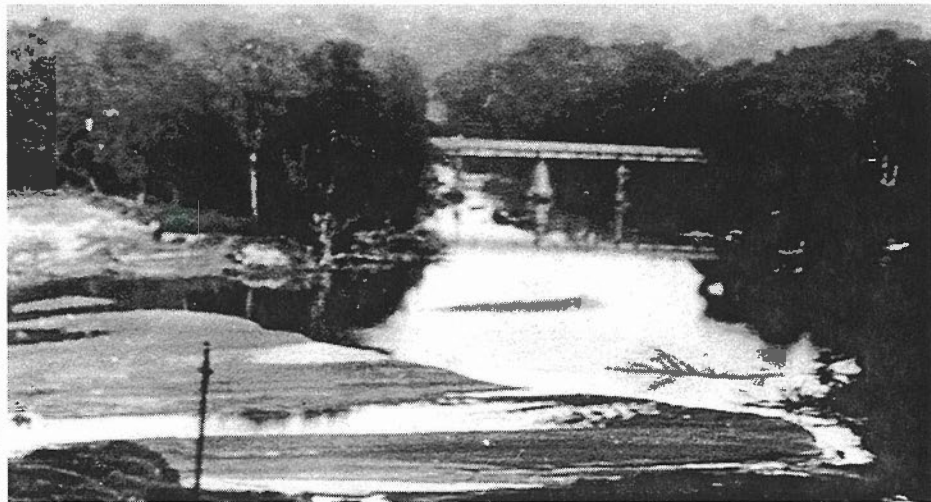
Figure 24. View of the temporary bridge taken from on top of the dam in 1930 (courtesy of SCE&G).

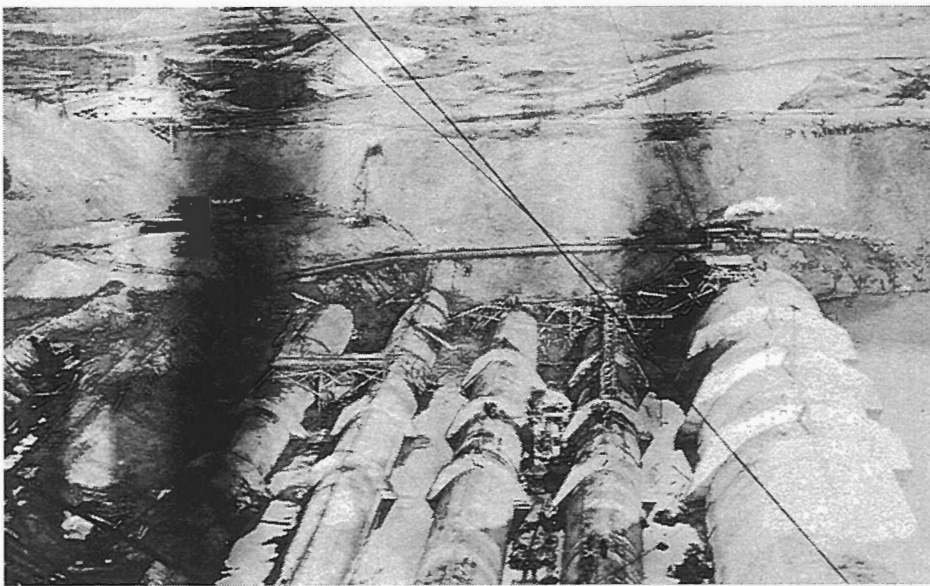
Figure 25. View of the penstock construction on January 3, 1929 looking east, into the survey area. Note the extensive clearing and ground disturbance from construction. (Duncan, Kinard, Sanders, and Tucker Family Album, 1928-1929; Courtesy of South Caroliniana Library, University of South Carolina).

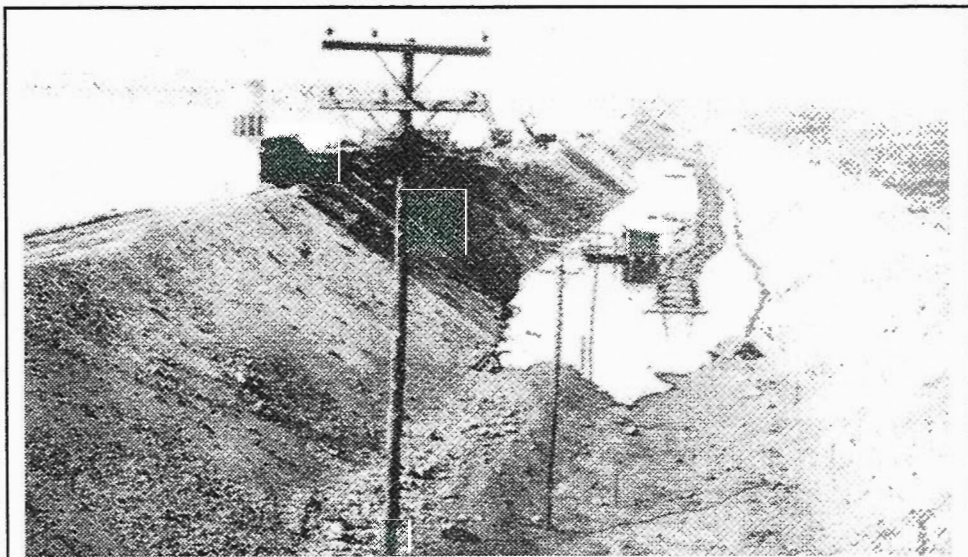
Figure 26. View of dam construction looking north. In the center is the segregation pool, which formed the center clay core of the dam (courtesy of SCE&G).

Once the water could be diverted from the river bed through the arched conduit, construction began on the dam itself. The area under the dam was extensively grubbed, with the middle third of the dam footprint being graded down to bedrock. The center of the dam had a clay

core, set by use of segregation pool. Clay and soil was dumped on both sides of this segregation pool and was sprayed by "five scows" using nozzles discharging 750 gallons of water per minute at a pressure of about 125 psi. Directed against the

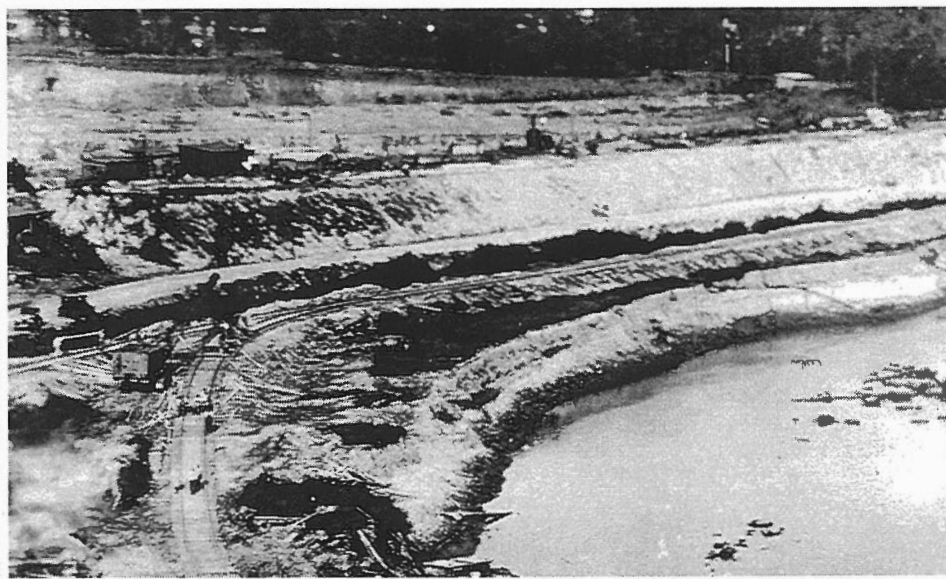
Figure 27. View east of the north bank of the Saluda, east of the dam in 1930. Note the extensive construction disturbance, including complete denuding of the floodplain area (courtesy of SCE&G).

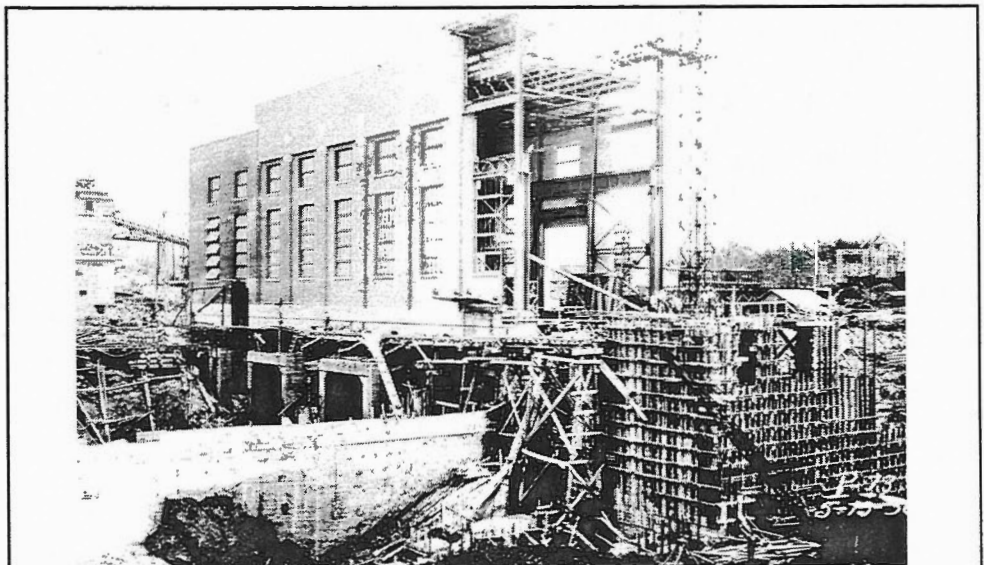
Figure 28. View of the Saluda Hydroelectric powerhouse under construction, looking northeast. At the right hand side is the substation lot (courtesy of SCE&G).

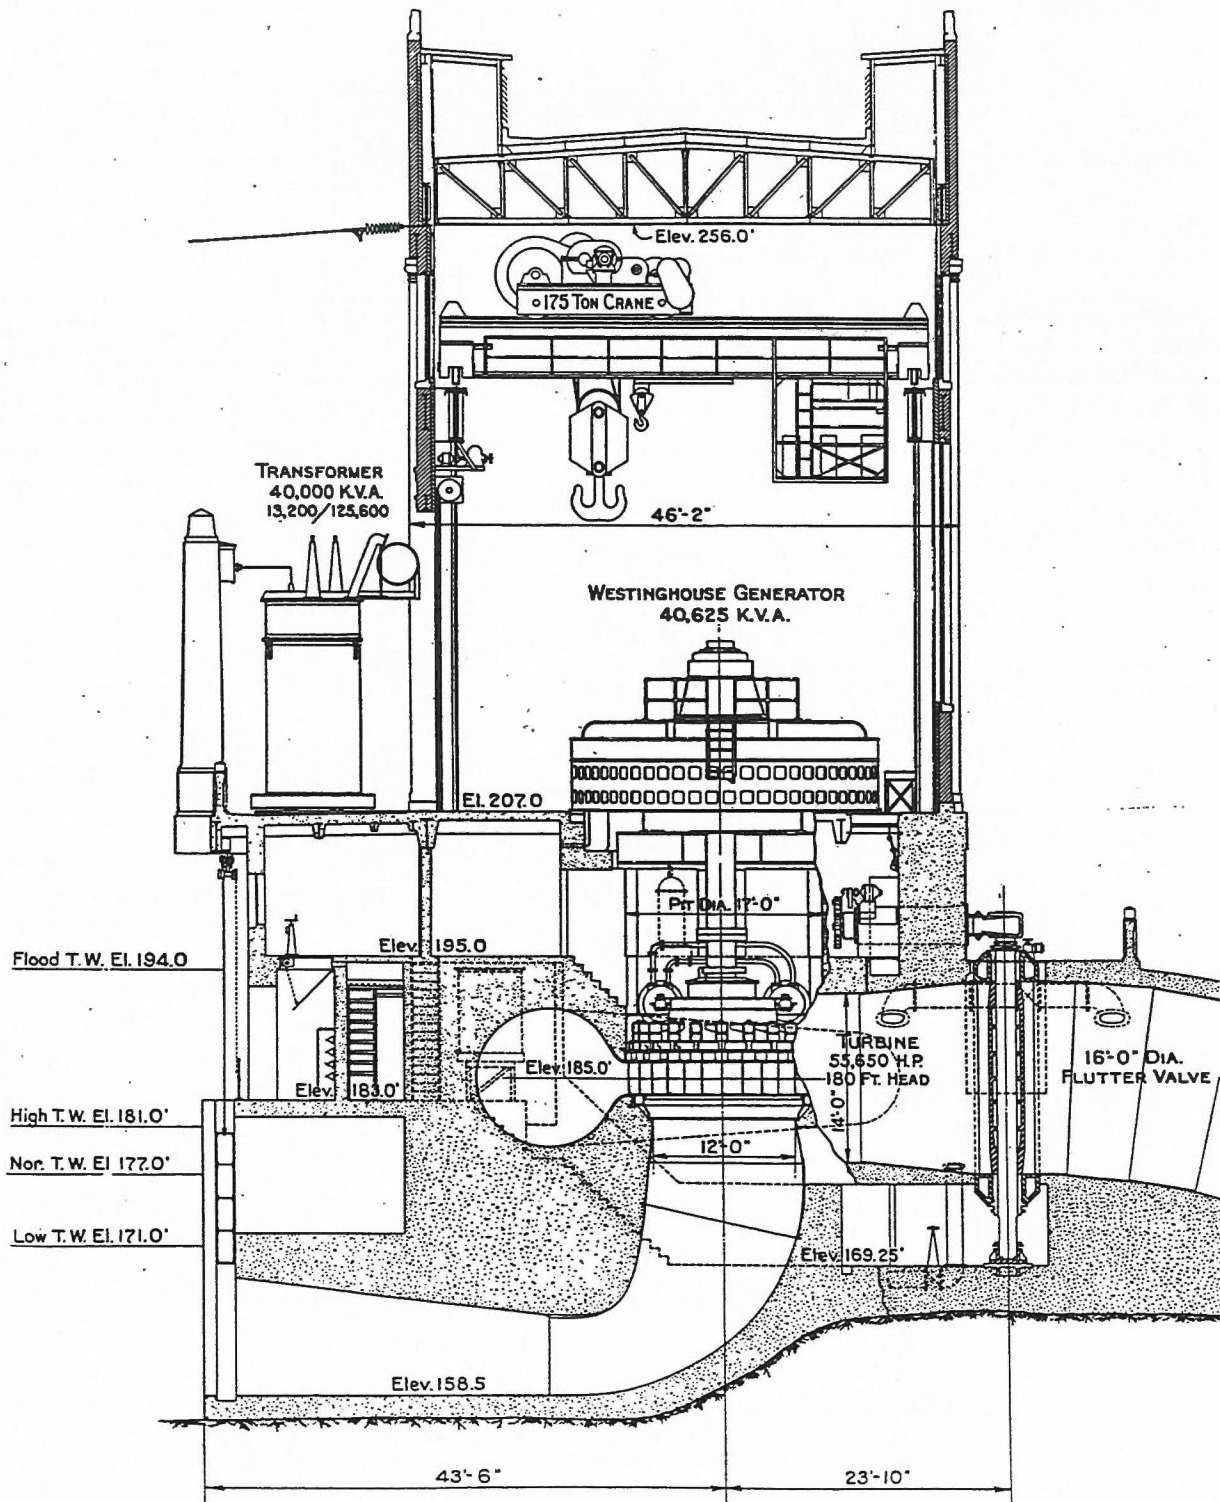
Figure 31. Cross section view of the Saluda powerhouse (adapted from Associated Gas & Electric System n.d.:29).

feet tall, was built of concrete, steel, and brick. It was equipped with four 55,650 HP turbines. Two surge tanks, 38 feet in diameter and 219 feet tall, earth banks on both sides, this spray washed the fine materials down into the segregation pond, where they settled out. Gradually the segregation pond was built up, forming the center clay core of the dam. Both unwashed and washed soils formed the upstream and downstream sides of the dam. The theory of this type of dam construction was that the core, through time, "becomes like hardened cement or very dense, dry clay" (Associated Gas & Electric System n.d.:21).

feet tall, was built of concrete, steel, and brick. It was equipped with four 55,650 HP turbines. Two surge tanks, 38 feet in diameter and 219 feet tall,

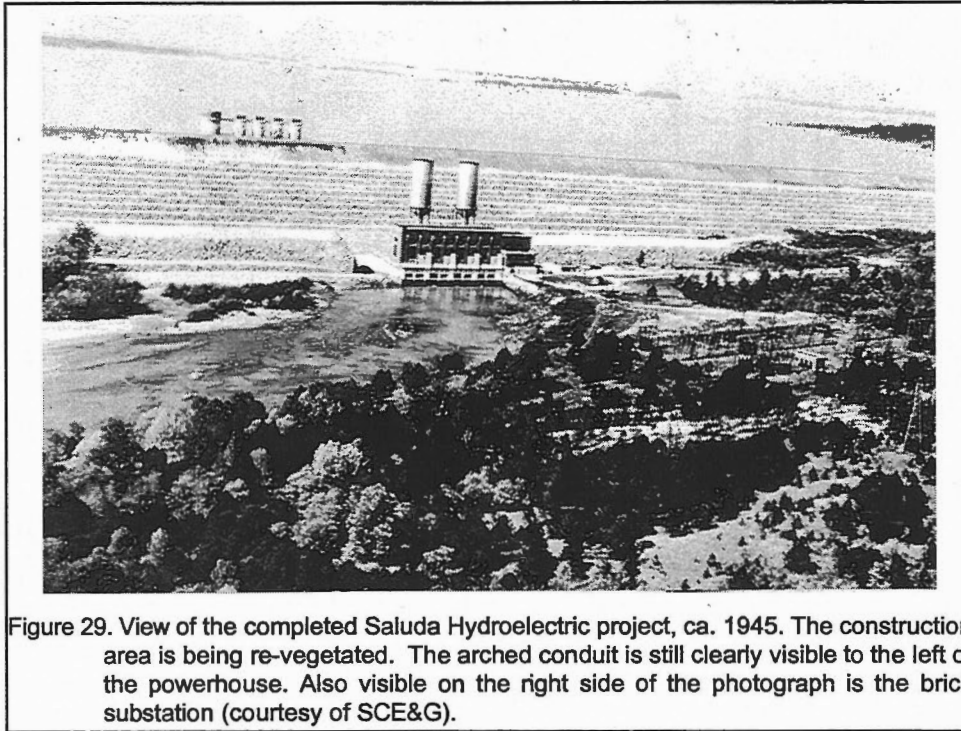
Figure 29. View of the completed Saluda Hydroelectric project, ca. 1945. The construction area is being re-vegetated. The arched conduit is still clearly visible to the left of the powerhouse. Also visible on the right side of the photograph is the brick substation (courtesy of SCE&G).

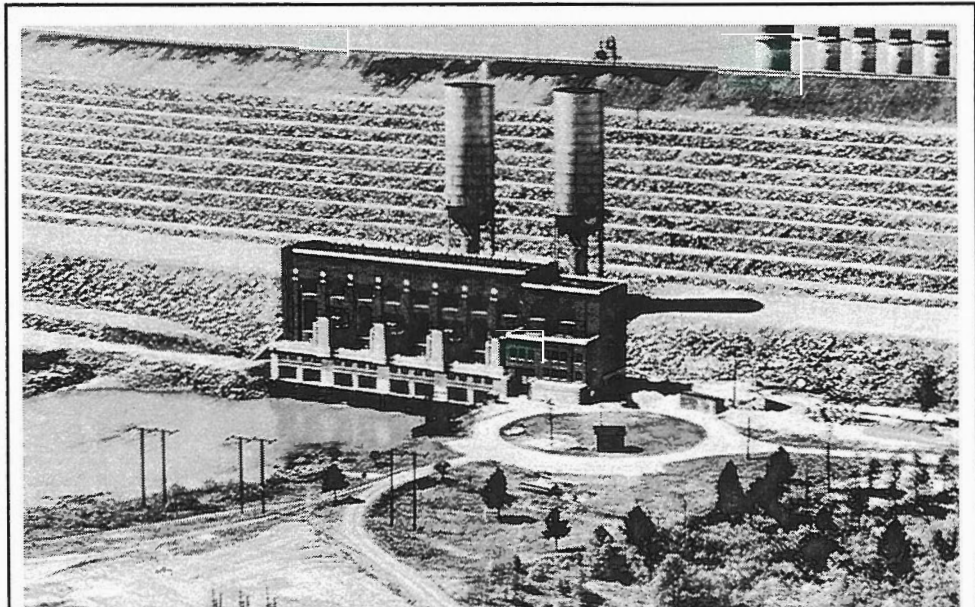
Figure 30. Airplane view of the Saluda dam and powerhouse from about 1944. The arched conduit is barely visible, having been extended when rip rap was added (courtesy of SCE&G).

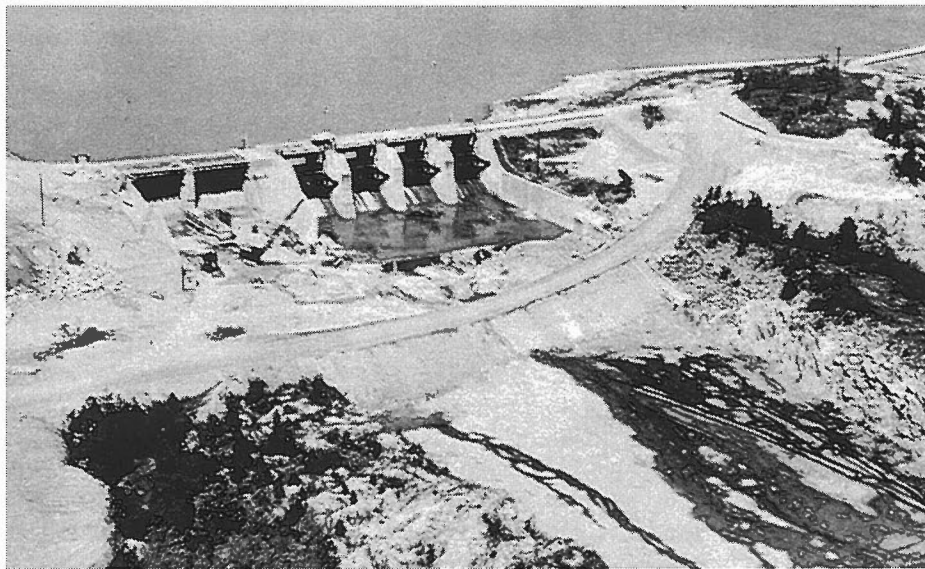
Figure 33. View of spillway gate construction, ca. 1945. The Yninger Cemetery is shown at the far right of the photograph (courtesy of SCE&G).

the ridge to the southeast and Figure 33 shows the cemetery in the midst of the spillway expansion in the early 1940s. Given this level of construction it is somewhat amazing that the cemetery has survived so well preserved.

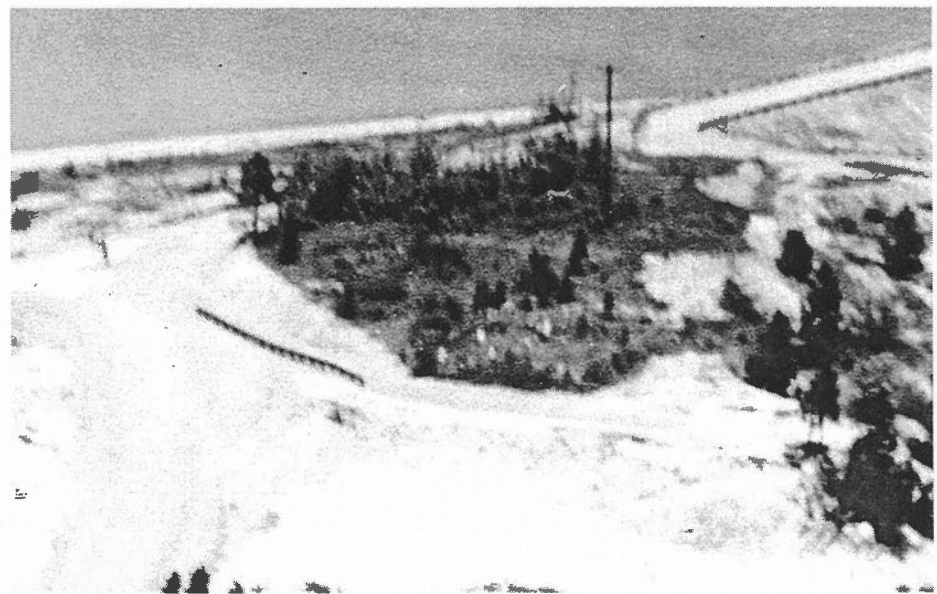
Figure 34. Close-up of the Yninger Cemetery shown in Figure 33.

(Wingfield and Henkel 1942:238). It was during this work that Swannea Reentsjerna also remembers, "during that time you couldn't use the dam. So they used the terraces on the side of the dam for the road. One terrace was used to go and one was used to come" (EAGLE Students 1988:7). A photograph showing the construction of the additional Tainter Gates (Figure 33) is of special interest since it also shows the Yninger Cemetery. What appear to be eight stones are visible within a square formed by vegetation, as though growing up along a fence line (Figure 34).

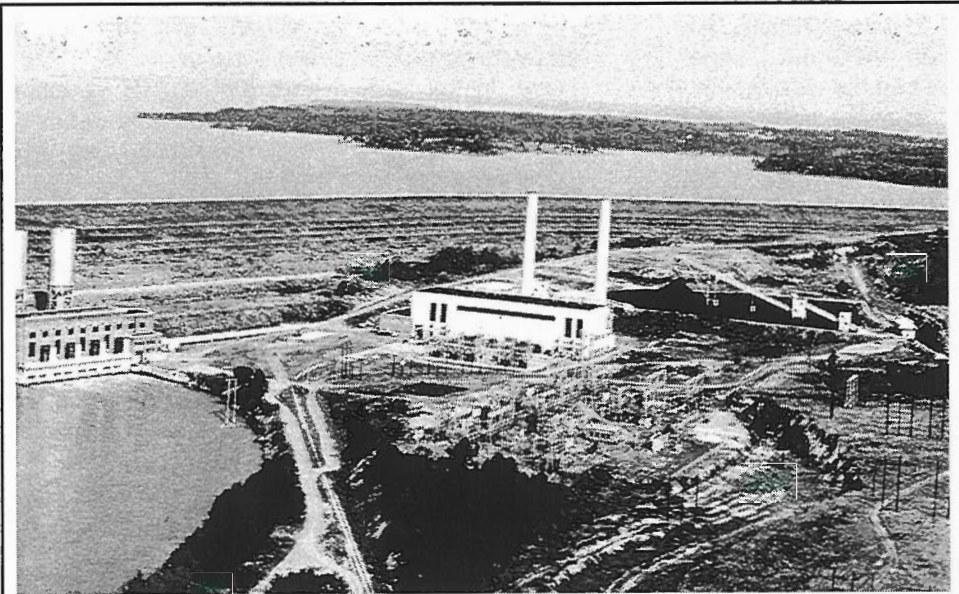
Figure 35. View of the completed McMeekin Station, May 8, 1961. Note how the ridge to the east continues to be cut away (courtesy of SCE&G).

The main building, on a concrete slab foundation, has structural steel framing, corrugated asbestos siding, corrugated glass, aluminum louvers, and a flat roof. An interesting "advancement" for the time was to leave part of the boilers, superheaters, air heaters, and water storage tanks unenclosed outside — reducing ventilating problems. In addition, the use of controlled circulation boilers allowed a significant

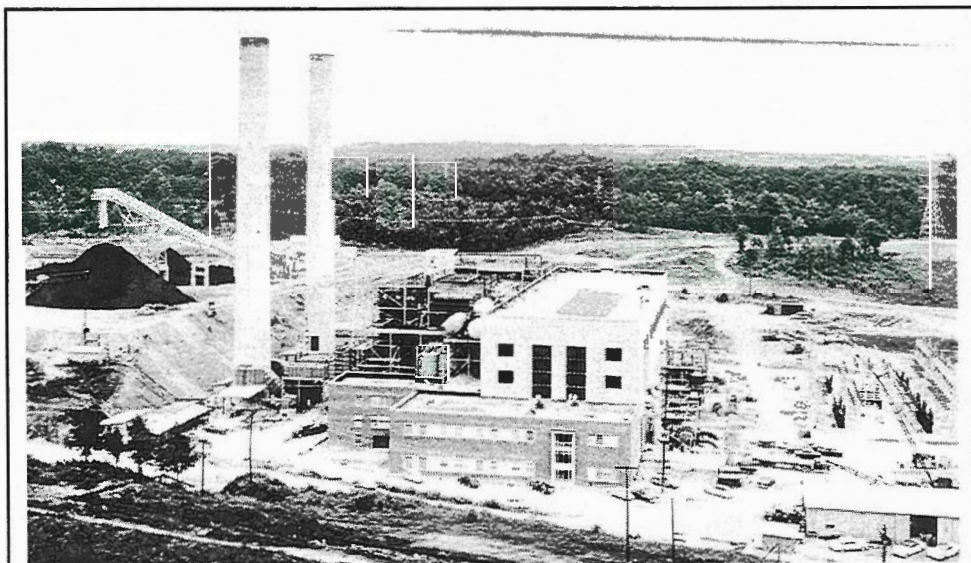
Figure 36. Close-up view of the McMeekin Station from the dam, ca. 1970 (courtesy of SCE&G).

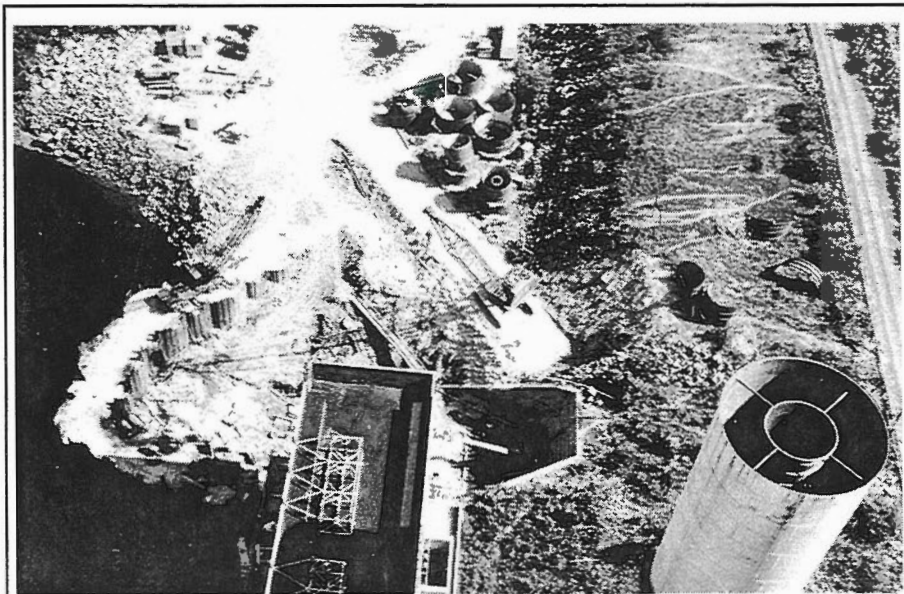
Figure 37. Expansion of the Saluda Hydroelectric plant ca. 1971 (courtesy of SCE&G).

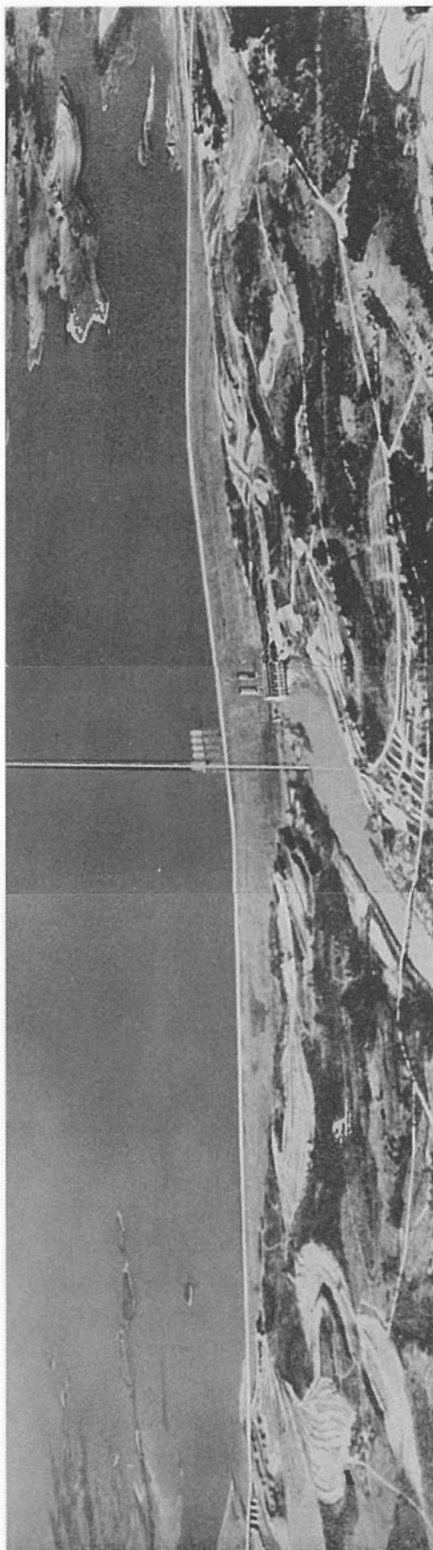
Figure 38. Aerial view of the dam complex ca. 1930 (adapted from Associated Gas and Electric System n.d.).

There is an aerial photograph taken of the dam shortly after its completion. This illustration, while not particularly clear, reveals much of the damage to the landscape, especially in the immediate vicinity of the dam and along the immediate floodplain areas. There are numerous areas which were clear cut. Some are beginning to grow back up in second growth, but many others are still plaining visible in the photograph.
